Musterfläche zur Fassadensanierung

Fassadenrestaurierung der  
Physikalisch-Technischen Bundesanstalt, Observatorium  
2008

Restoration of The Façade of  
The Federal Agency For Physics And Technology  
Observatory (National Metrology Institute)  
2008

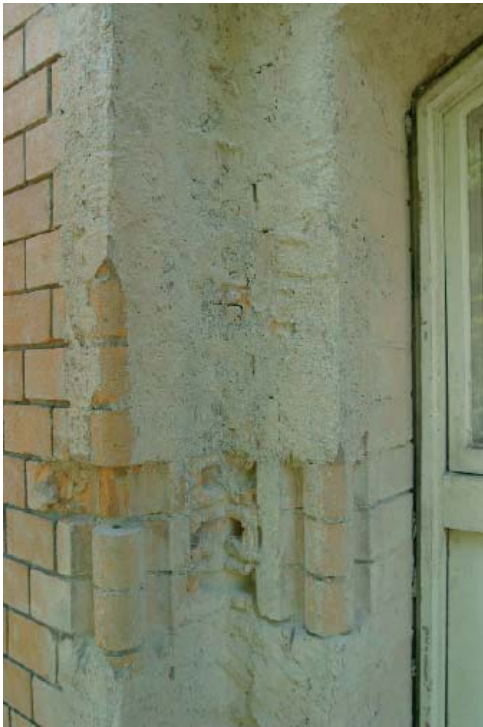
Beschädigte und überputzte Formsteingewände

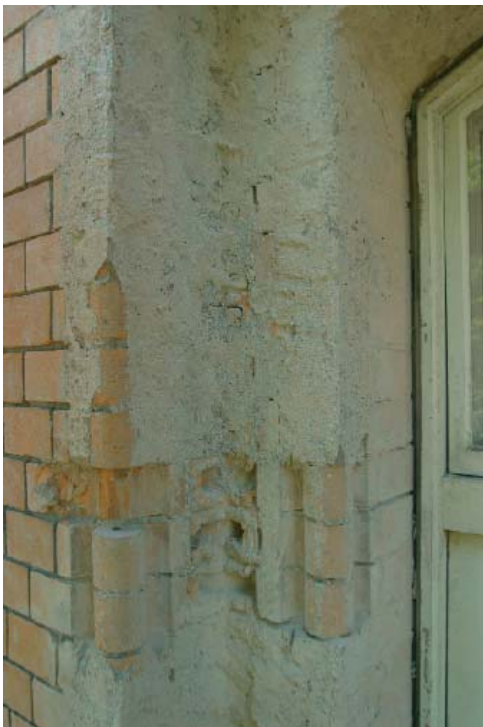
actual condition of the façade
